Impact of Electrical Energy Sources on Historical Buildings

Dr. Yasser Osman El-Gammal, Dr. Sanaa Ibrahim Abd El-Maksud

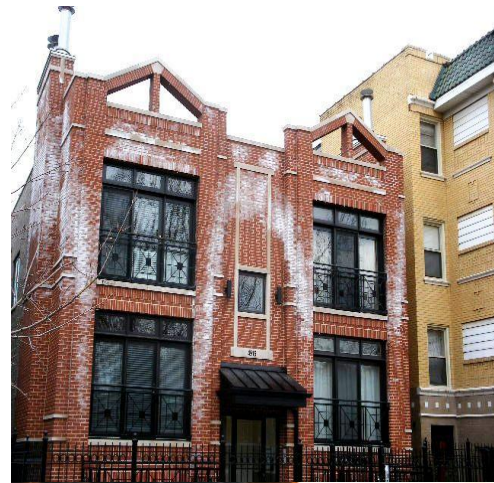
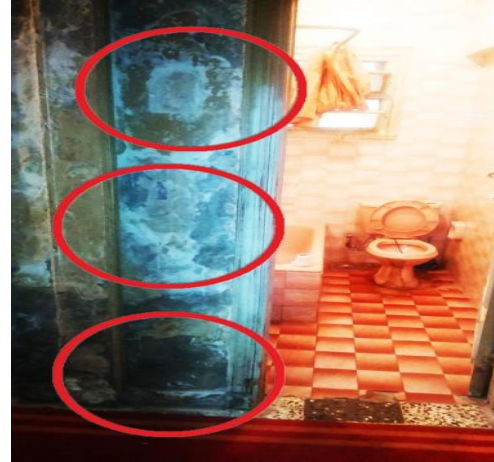
The two building examples show that "Efflorescence" may happen to masonry surfaces regardless weather conditions; however, a hot climate may accelerate the appearance of "Efflorescence", since such phenomena is closely related to the movement and evaporation of water in masonry. Figure (1) shows "Efflorescence" on the exterior walls of a modern building in "Canada" with its external walls made of bricks.⁴

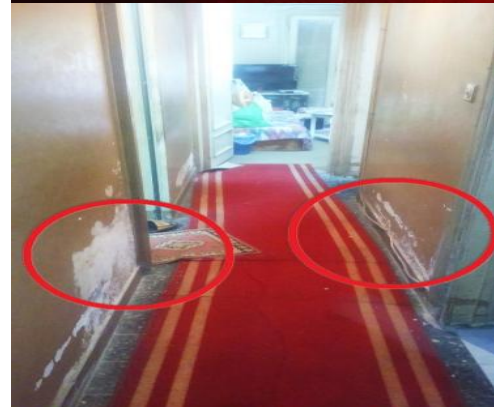
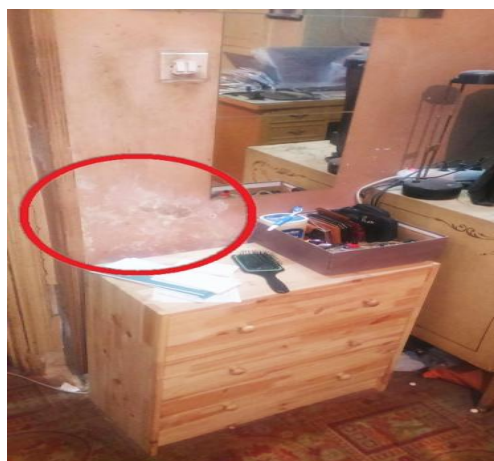
Figure (2) shows "Efflorescence" on the interior walls of a modern apartment in "Egypt" with its interior walls also made of bricks.⁵

Figure2. Shows "Efflorescence" on the interior walls of a modern apartment in Egypt, Shows the effect almost reaching the top of the bathroom walls from

the side facing the corridor. Middle: Shows "Efflorescence" affecting both walls of the apartment corridor leading to bedrooms and living area. Shows "Efflorescence" affecting the wall separating the Bathroom from the bedroom. Reference: [Researcher]

In figure (2), it is noticed that interior walls that are closer to water sources and humidity coming from the bathroom are more affected by "Efflorescence" than those located at further distances, however, water sources are not limited to kitchens or bathrooms as domestic wet areas; water may still come from the soil beneath; passing through concrete foundations to penetrate walls of apartments, especially those allocated in buildings ground floors.

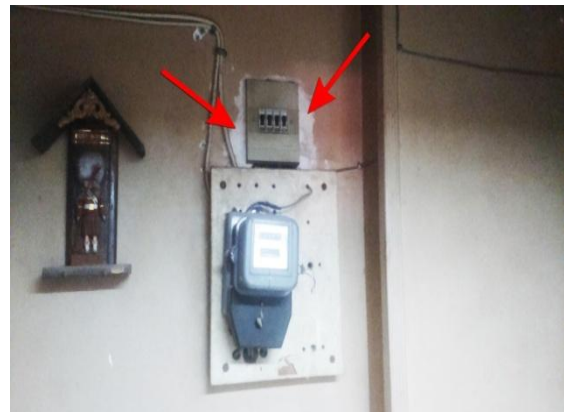
In the following figure (4), "Efflorescence" is spotted around the "Electric Panel" ⁷ placed over an entrance lobby brick wall of a modern apartment in a multistory residential building, located in Cairo, Egypt. The later was completely built in mid seventies of the twentieth century. Observation in figure (4) implies to the accumulation of "Efflorescence" on the wall mainly due to the near presence of an electrical source of energy

Figure4. Shows the accumulation of "Efflorescence" on the wall due to the near presence of an Electrical source of energy. Reference: [Researcher]

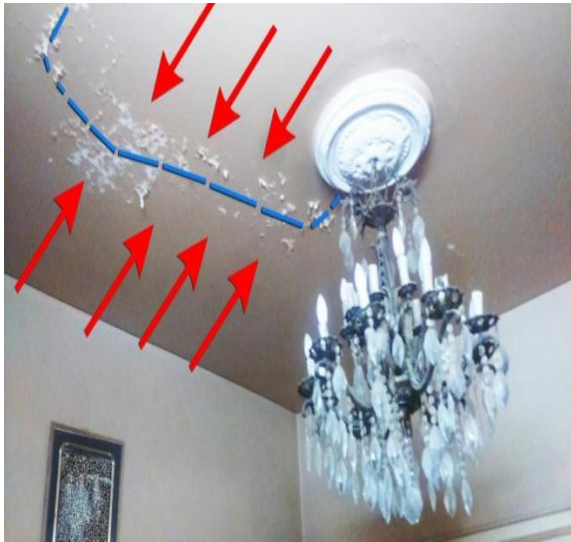
"Efflorescence" formed around electrical conduits⁸ embedded in the grouted⁹ crevices¹⁰ that are leading to the ceiling chandelier. The accumulated salts beneath caused the paint to crack¹¹.

Figure 5. Shows "Efflorescence" accumulated under a painted ceiling of the saloon in the same apartment presented above. "Efflorescence" formed around electrical conduits that are embedded in the grouted crevices leading to the ceiling chandelier. Reference: [Researcher]

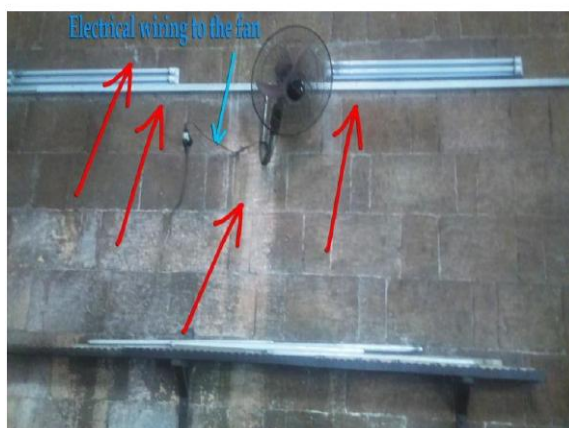
Figure7. Top and Bottom pictures are showing "Efflorescence" forming around plastic conduits, and fans installed over lime stone walls of the prayer hall inside prince "Zulfikar" mosque, Reference: [Researcher]

The following figure (7) shows "Efflorescence" forming around plastic conduits, and fans

installed over lime stone walls of the prayer hall inside prince "Zulfikar" mosque

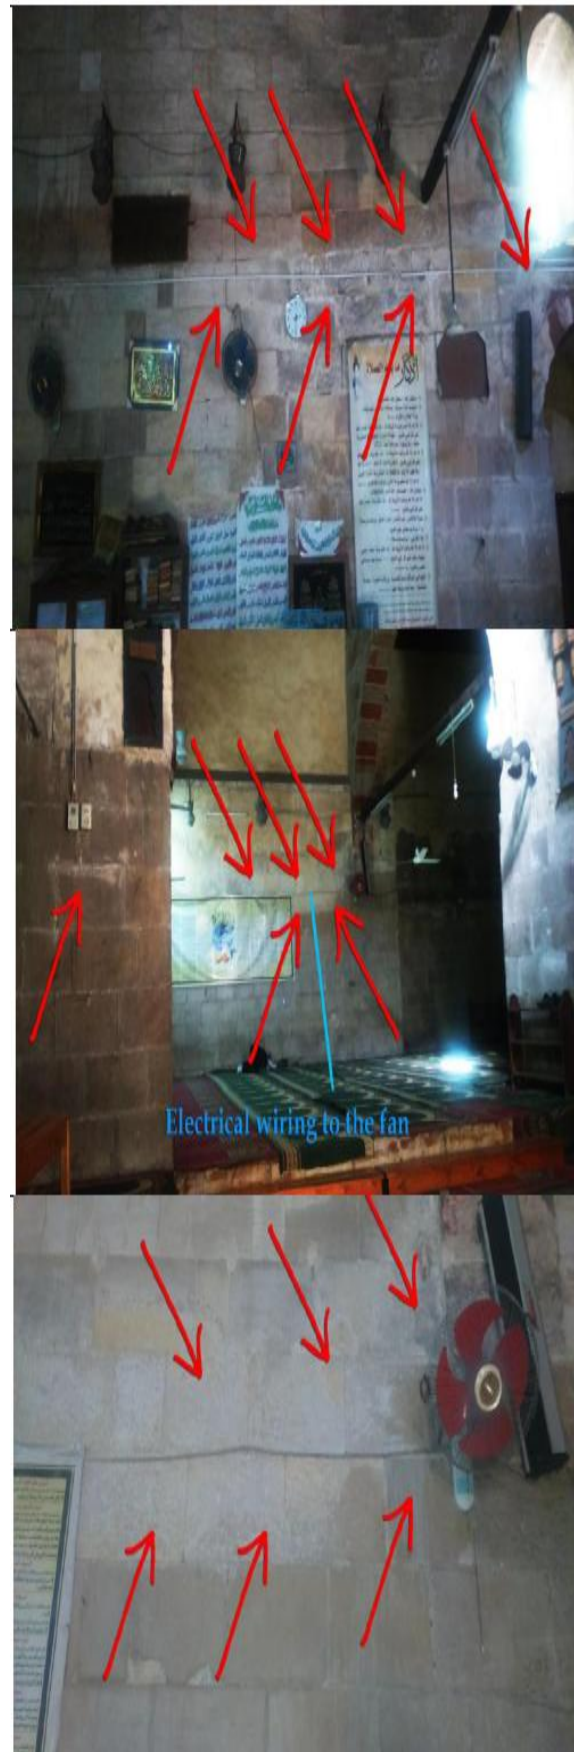
The top, middle, and bottom (Zoom in) pictures in figure (9) show "Efflorescence" forming around plastic conduits, and fans installed over lime stone walls of the prayer hall inside "Prince Timraz Ahmadi" mosque. Also, Figure (10) is showing "Efflorescence" forming around the fan and sound speaker installed over the "Mihrab"¹⁸ area of its prayer hall

Figure9. Top, middle, and bottom (Zoom in) pictures, are showing "Efflorescence" forming around plastic conduits, and fans installed over lime stone walls of the prayer hall inside "Prince Timraz Ahmadi" mosque. Reference: [Researcher].

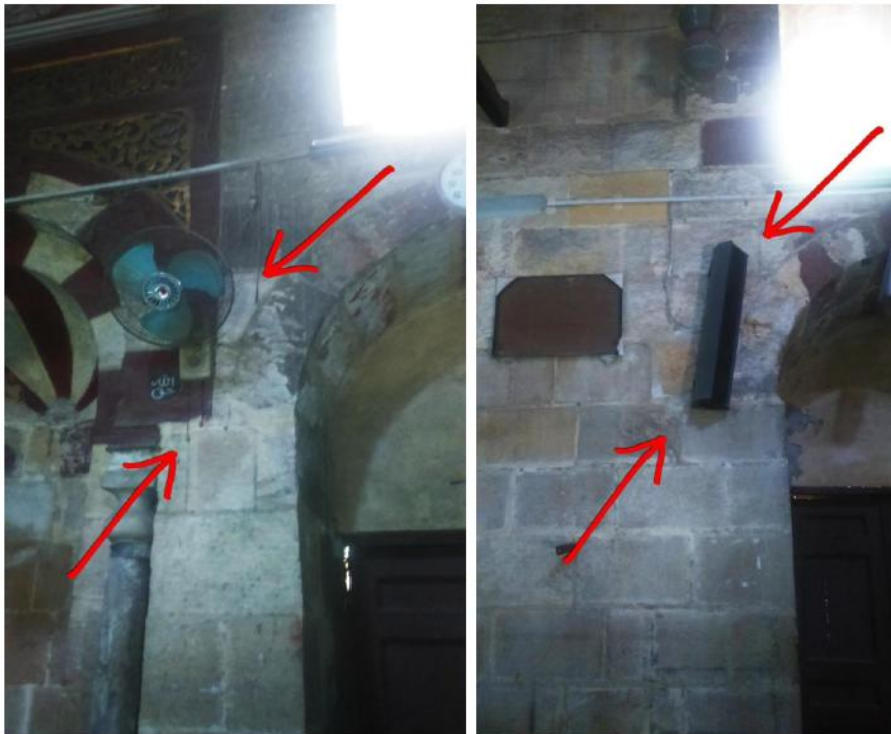
Figure10. Left, Right, Show "Efflorescence" forming around the fan and sound speaker installed over the "Mihrab" area of the "Prince Timraz Ahmadi" mosque Prayer hall. Reference: [Researcher]

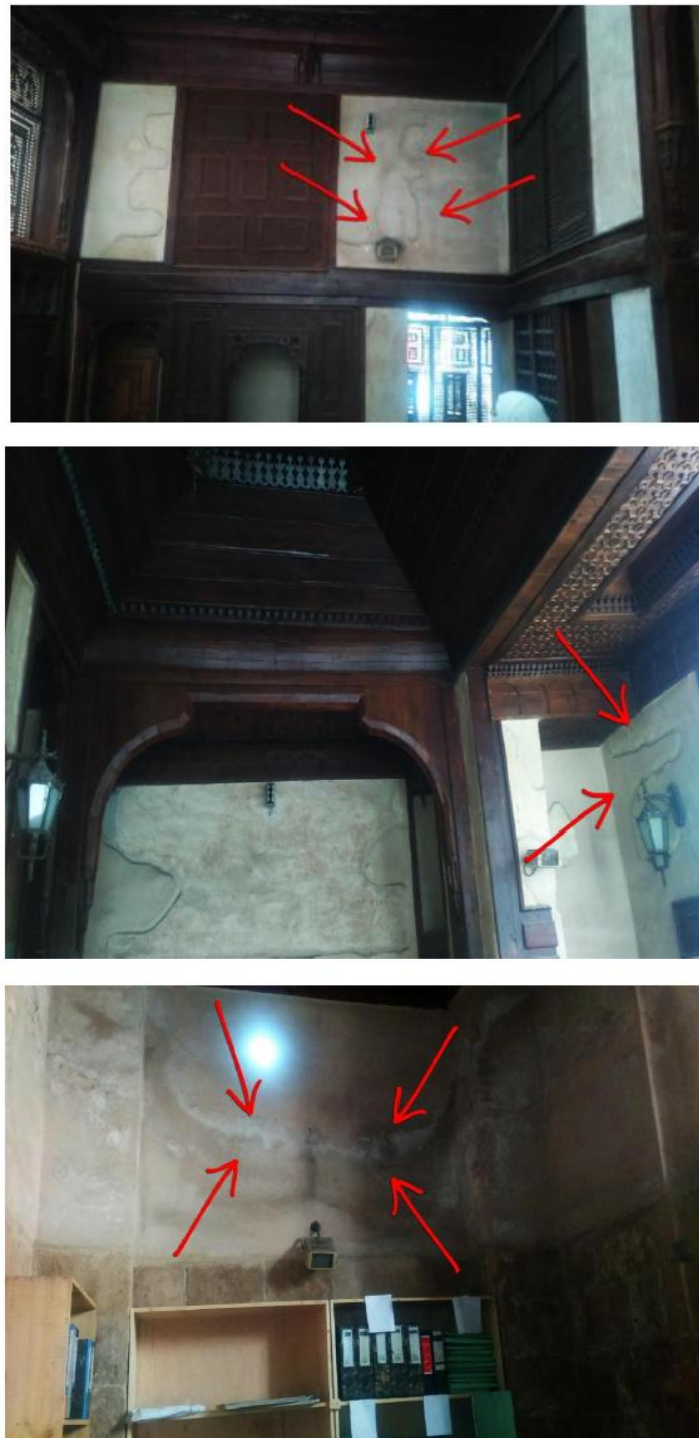
Figure12. Top, Middle, Bottom pictures are showing "Efflorescence" forming around sound speakers, and electrical lanterns inside the "Haramlek", and also around wiring extensions embedded inside the wall crevices of the surveillance control room at the ground floor of the house of "Sheikh Abu El-Anwar Al-Sadat". Reference: [Researcher]

The top, middle, and bottom pictures in figure (12): show "Efflorescence" forming around sound speakers, and electrical lanterns inside the "Haramlek"²¹, and also around wiring

extensions embedded inside the wall crevices of the surveillance control room at the ground floor

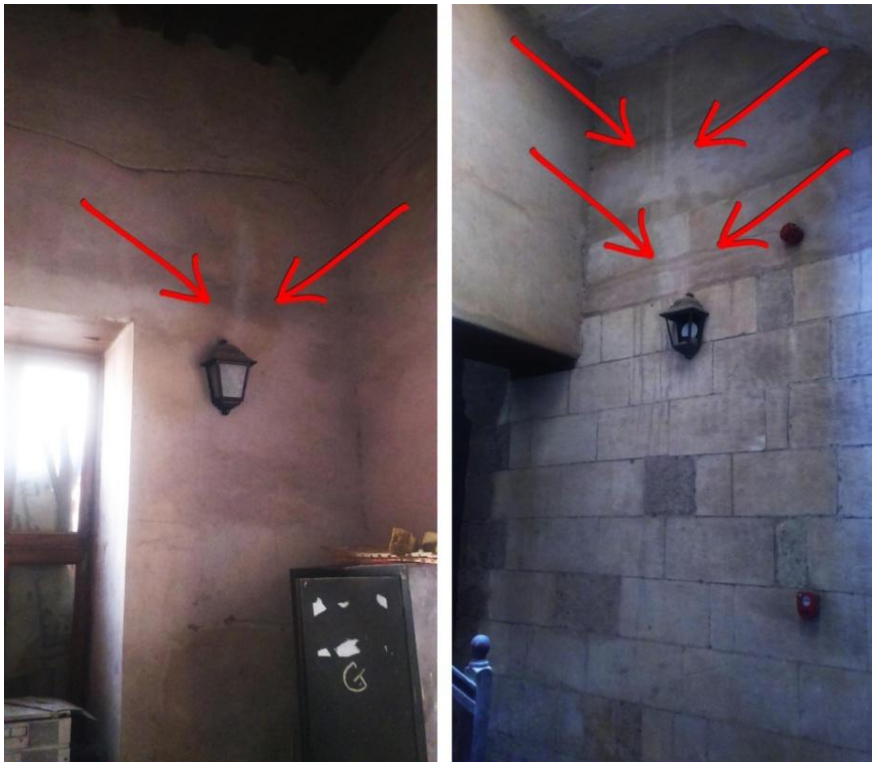
of the house of "Sheikh Abu El-Anwar Al-Sadat". Figure (13) Is also showing

"Efflorescence" forming around installed electrical lanterns inside the house staircase.

Figure13. Is also showing "Efflorescence" forming around installed electrical lanterns inside the "Sheikh Abu El-Anwar Al-Sadat" staircase. Reference: [Researcher]

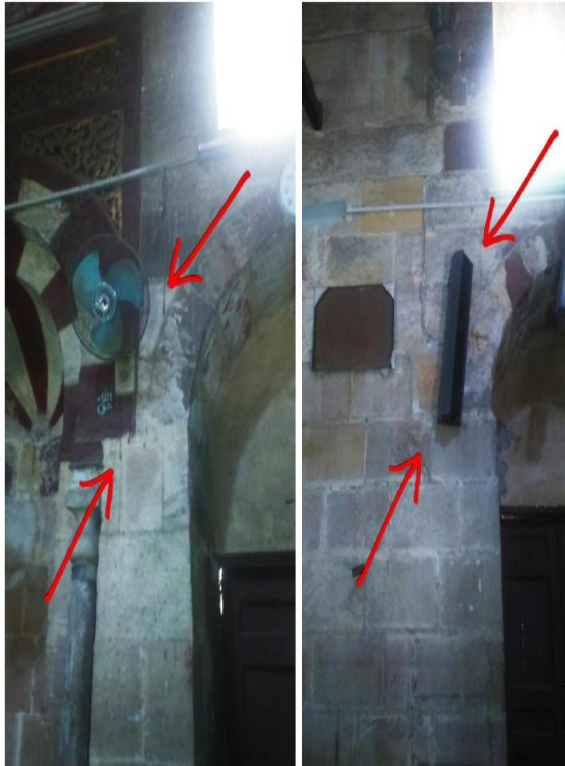
Figure15. Shows the formation of "Efflorescence" around sound speakers installed over the lime stone walls of the "Mustafa Fadil" Pasha mosque entrance lobby. Reference: [Researcher]

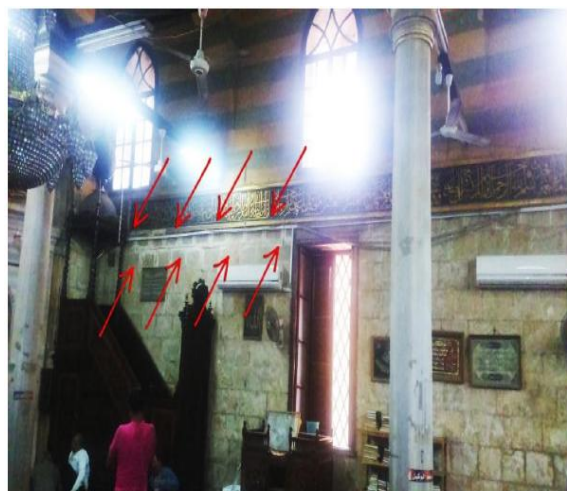
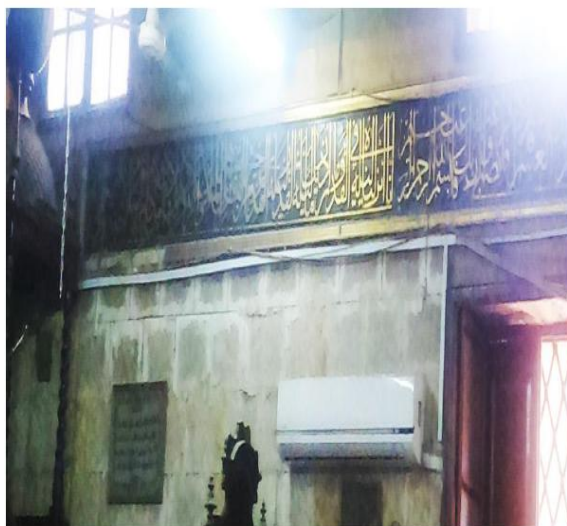
Figure17. Top and Bottom (Zoom in) pictures are showing the formation of "Efflorescence" around plastic conduits extended over the walls of the

"Sheikh Saleh Abu Hadid" Mosque prayer hall. Reference: [Researcher]

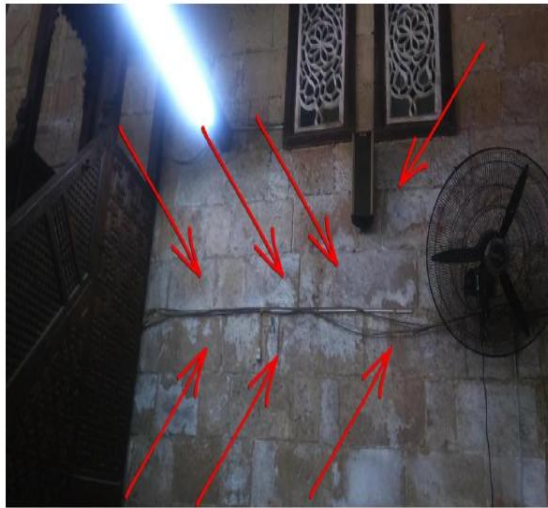
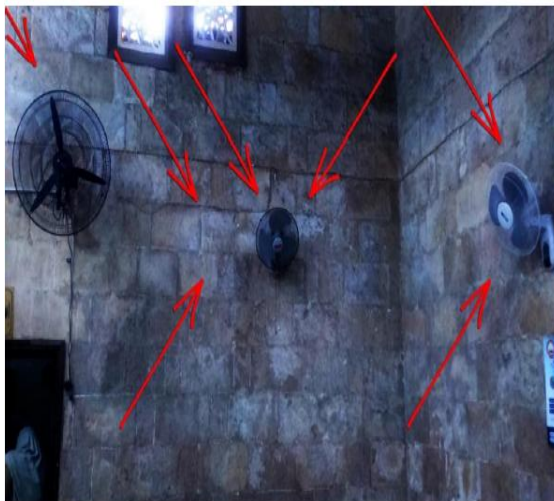
The top and bottom pictures of figure (19) are showing the formation of "Efflorescence" around bare electrical wiring extended to fans over the walls of the mosque prayer hall. Also, the left and right pictures of figure (20) are showing the formation of "Efflorescence" around the fan installed at the "Mihrab", and around a series of electrical panels found in "Hassan Pasha Taher" Mosque electromechanical room.

Figure19. Top and Bottom Pictures are showing the formation of "Efflorescence" around bare electrical wiring extended to fans over the walls of "Hassan Pasha Taher" Mosque prayer hall. Reference: [Researcher]

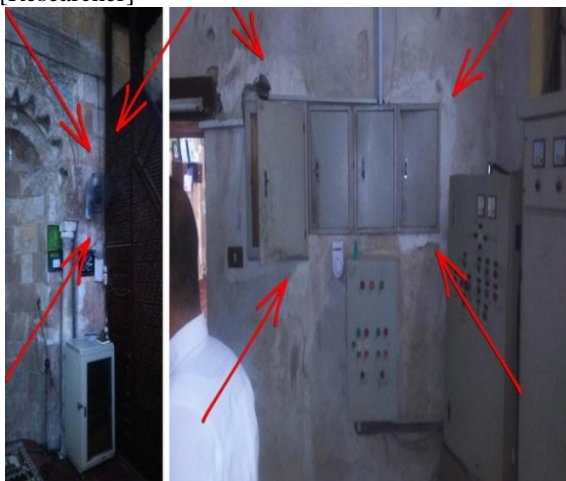
Figure20. Left and right pictures are showing the formation of "Efflorescence" around the fan installed at the "Mihrab", and around a series of electrical panels that are found in "Hassan Pasha Taher" Mosque electromechanical room. Reference: [Researcher]
