Sunday Shende Kometa\*, Dereck Mbeh Petiangma\*\* & Edwin Mua Kang \*\*

**Citation:** Sunday Shende Kometa et.al, "Effectiveness of Flood Adaptation Strategies to Land Use Dynamics in Ngoketunjia Division, North West Region of Cameroon", Annals of Geographical Studies, 4(1), 2021, pp 16-26. DOI: https://doi.org/10.22259/2642-9136.0401003

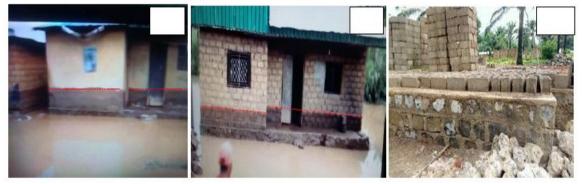
The images in Figures 10a, b,and c flaunt the design heights of some building foundations in the Division. Figures 10a and 10b show substandard foundations in Babessi Sub Division that were submerged during the August 2019 flood. The water mark (delimited by the red line) on both buildings represent the flood

height which was approximately 50 cm above the heights of both foundations (height of each block is approximately 20cm). Figure 9c portrays a relatively more resilient foundation designed in the flood prone zone of Ndop Central Sub Division.

Figure 9: Designed Heights of Some Foundations in the Flood Prone Zones of Ngoketunjia Source: Fieldwork, (2019)

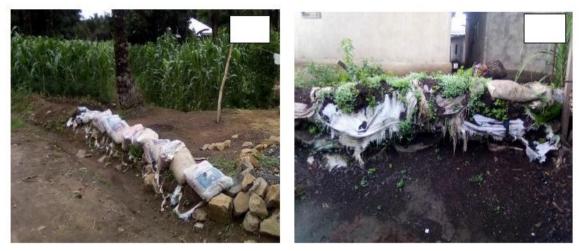
Figure 13a and 13b: Sand Bags Constructed in Some Parts of the Division

Comparatively, it is abundantly clear that the sand bags in Figures 13 are below FEMA recommended standards in terms of width and height as exhibited by Figure 12. The sand bags in Figure 13 equally look too "old" and therefore are at variance with FEMA recommendation of regular maintenance since the institution regards them as temporal flood mitigation strategies. In terms of content, field work revealed that a significant proportion of bags in Ngoketunjia Division were filled with soil, casting doubts on whether they should be termed sand bags or "soil bags". Though not adaptation strategies, culverts and bridges in flood zones greatly influence vulnerability. These structures can affect the distribution of relief aid as well as evacuation of population at risks. Based on field results, 17.4% and 30.7% of the bridges and culverts in their neighbourhoods are sometimes submerged by flood water. Though this indicates that most of these structures respect certain standards, it equally indicates that not all are standardised or comply to the norms as spelled out by FEMA..

Sand bags have been used in Ngoketunjia Division to control and protect assets from floods and to prevent erosion. FEMA has outlined certain technical standards for the use of sand bags which amongst others encompasses its height in relation to width, alignment, and content. Figure 11 depicts an ideal FEMA recommended standard for the construction of sand bags while Figure 12 displays images of sand bags constructed in some parts of Ngoketunjia Division to combat floods.
