Changes in River Channel form and Geometry below Dam Reservoir in Karadua Catchment, Katsina State, Nigeria

This paper studied the effects of dam on the downstream changes in river channel form and geometry below dam reservoir in karadua catchment, katsina state, Nigeria.

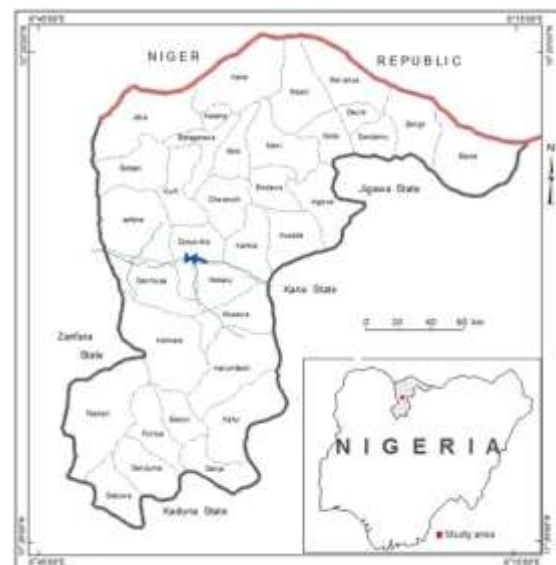
Figure1. Map of the Study area showing the Karadua River

The study Catchment is the Karadua basin located in Katsina State in northern part of Nigeria. It lies between 12o 00' and 12o 50' north of the Equator, and between 07o00' and 08o00' east of Greenwich (figure 1). The area is found within the southern margin of the Mesozoic and tertiary lullameden basin of the South Sahara. The crystalline base portion of this area, predominantly consist of granite-magmatite and gneiss rock, (Kogbe, 1976).

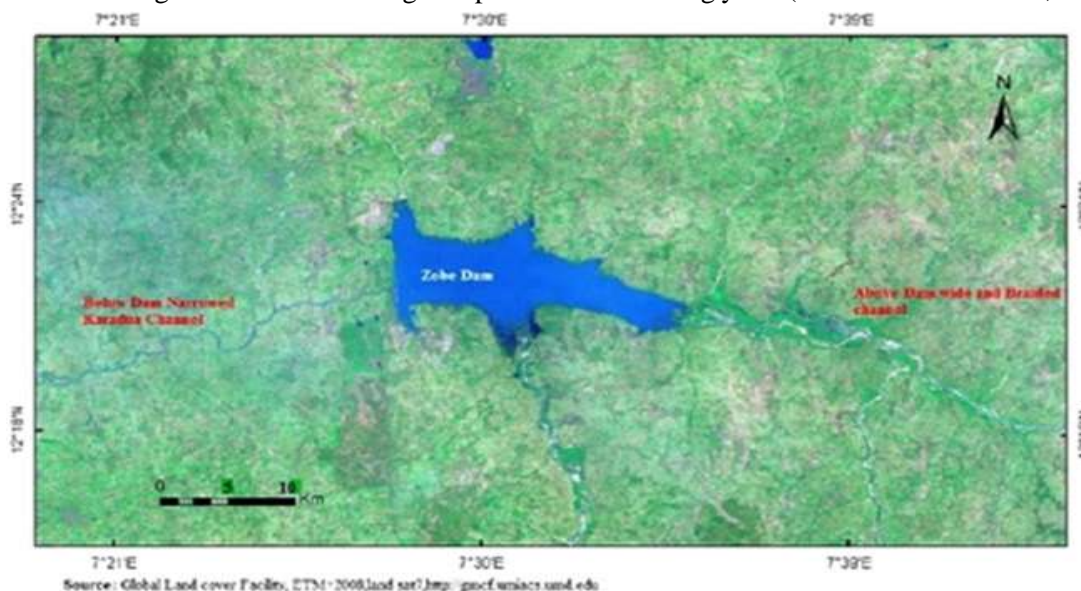
Figure2. Zobe Dam, Above Dam and Below Dam Karadua River Mophology

Dam period. This is because new tributaries joined the main river and increase the drainage area downstream. However, this situation reversed after reservoir operation; Bankfull width consistently decreased downstream and at nearly 2.5 times the rate it was increasing during the pre-Dam period. Figure 3 below shows a clear picture of that morphology. Decreasing channel width likely leads to increase in channel depth, which is in line with the Harvey and Schumm (1987) findings that the channel bed near the dam was armoured one year after dam construction and operation. This also reflects the prediction that channel bed would continue to erode downstream and become increasingly armoured in following years (Williams and Wolman, 1984).

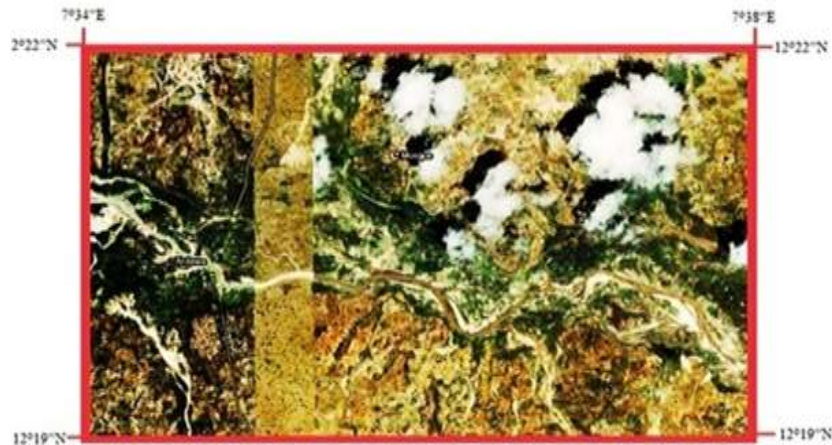
Figure3. Above Dam Karadua Braided Channel

spectacular pattern known as braiding. Figures 4 and 5 below show the braided channel at the above Zobe Dam river reach. The channel braided spectacularly at a stretch, winding through the wide sandy alluvium of the storm channel.

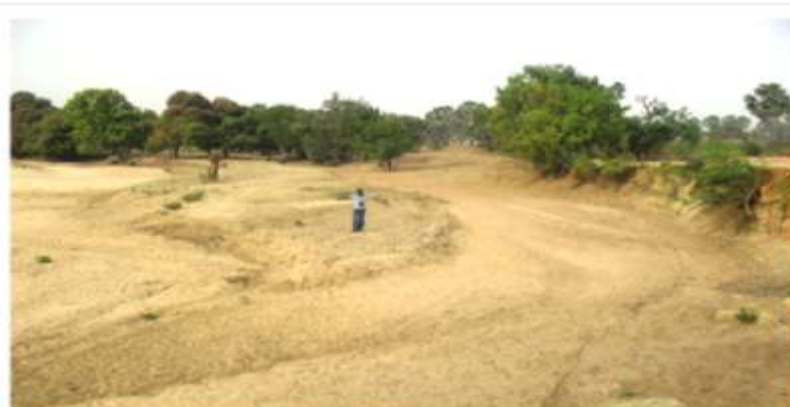
Figure4. A Braided Channel above the Dam reservoir

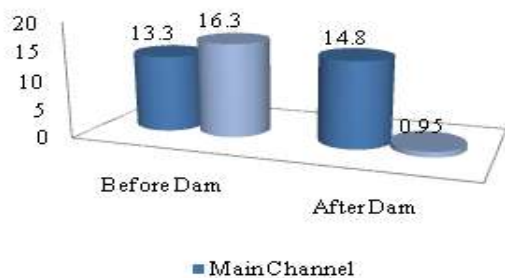
Figure 5. Pre and Post Dam Karadua Stream Length Characteristics

The result of the satellite image analysis shows that during the pre-Dam period, stream length varies in a similar magnitude both at below and above the Zobe dam river channels. Up till now the above dam stream maintained the same level of variation, while below dam reach experienced a 47% reduction in stream length. Table 2 and figure 6 below shows clearly the outcome. The analysis of the rate of stream length changes indicates that along the main Karadua channel, stream length changes were not significantly different. But when the braided channels are added up to the main channel, the reverse is the case.

The fact that Regulated stream length varied 47% less during the post-Dam period supports the idea that flow regulated by dams reduces the frequency of overbank flows and episodic channel migration within the entrenched channel. This is further supported by the findings of this work that the stream used as control varied in length consistently during both periods. The variability exhibits same character with the regulated stream at pre-Dam period. Once the regulated channel became vertically and horizontally contained, it likely becomes unable to migrate regularly as it does during pre-dam flood events. Figure 7 and 8 shows a clear picture of this situation. Looking at the figures closely, it is clear to see that braided channel (figure. 7) before Dam construction has changed in to a single channel flowing with only slight channel shifting in (figure 8). However, an examination of the entire regulated study reach revealed that along the entire stream length, only at the largest curve of the meander, about 5.2km away from the reservoir, shows a clear channel shifting. This alone yielded a difference of about -11.6%.

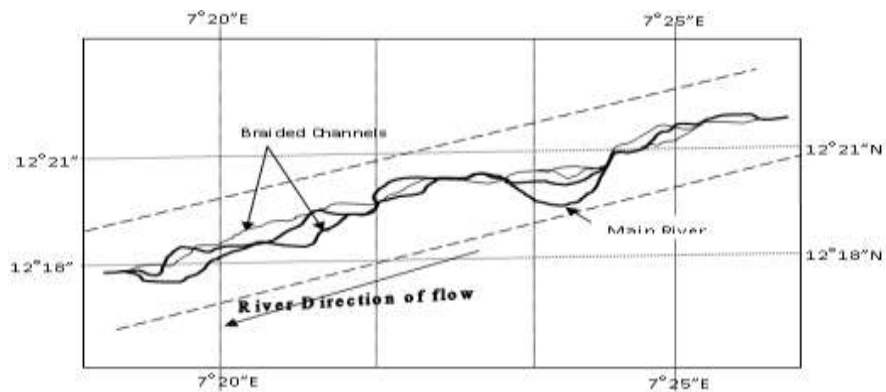
Figure 6. Below Dam Karadua River Section before the Dam Construction (1978) Evidence of river sinuosity and Braided Channels
